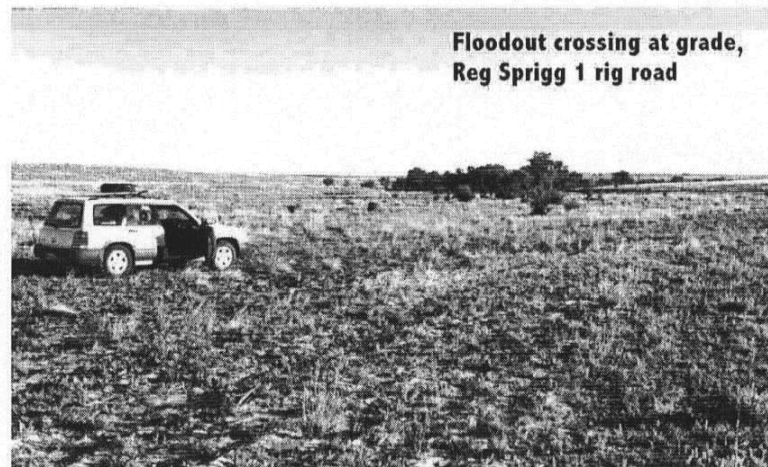
Figure 13. Floodout crossing, with red mulga on shallow channels downstream; ephemeral grasses.

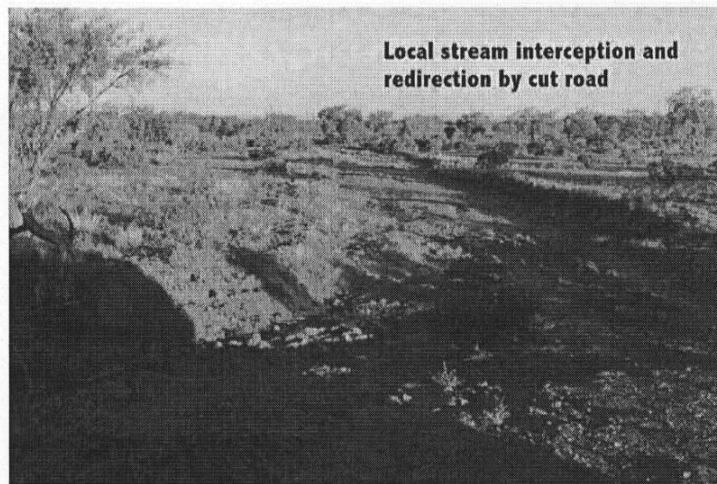
Figure 14. Watercourse in foreground diverted along road to a parallel watercourse
